DOT/FAA/AR-02/117

Crack Growth-Based Predictive
Methodologies for the
Maintenance of Structural Integrity
of Repaired and Nonrepaired
Aging Engine Stationary
Components

January 2003

Final Report

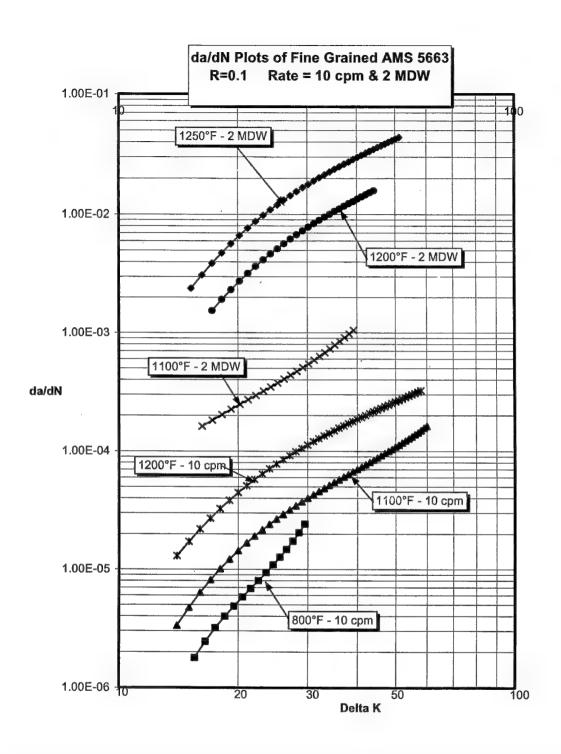
FIGURE 25. CRACK GROWTH RATE (da/dN) PLOTS FOR AMS 5663 WITH AN ASTM 8-10 GRAIN SIZE TESTED AT VARIOUS TEMPERATURES (The results are consistent with existing P&W database data and serves as a baseline against which to compare material with simulated heat treatments. Note the faster rates of the fine-grained material relative to coarse-grained material (figure 24), especially at temperatures at and above 1100°F.)

The non-HIP welds had a faster crack growth rate than the casting baseline by an average factor of 1.5 to 2.0X. This was still slower than the coarse-grain AMS 5663 rates and other AMS 5663 welds. It is difficult to explain this, being that the fusion zone areas of both AMS 5663 and PWA 1469 have identical microstructures. One fusion zone weld specimen was machined with the weld that was not properly aligned in the starting slot. Crack growth of this specimen was primarily through the specimen's base metal portion. When the HIP weld specimen was tested under 10 cpm loading, the crack growth rate was faster than the dwell-loaded base material at lower delta K values. However, the plots converged at higher (40) values. Results of the HIP welds tested under dwell conditions were the most dramatic. The two specimens tested under dwell loading were faster than the HIP baseline by factors of 13X and ~30X. The faster crack growing HIP weld had a rate that matched that of the fine-grain AMS 5663 tested under identical conditions (see figure 25).

Grain size effects on the crack growth rate of wrought Inconel 718 are well known and were confirmed with the AMS 5663 baseline test results as illustrated in figures 24 and 25. Test results achieved with the AMS 5663 welds were consistent with previously generated data. It is generally accepted that AMS 5663 forgings used to construct large static components, such as cases, are generally coarse grained. However, cutup analysis of the long time service cases (see section 2.1.4) have shown that very fine grain details may get into a case assembly.

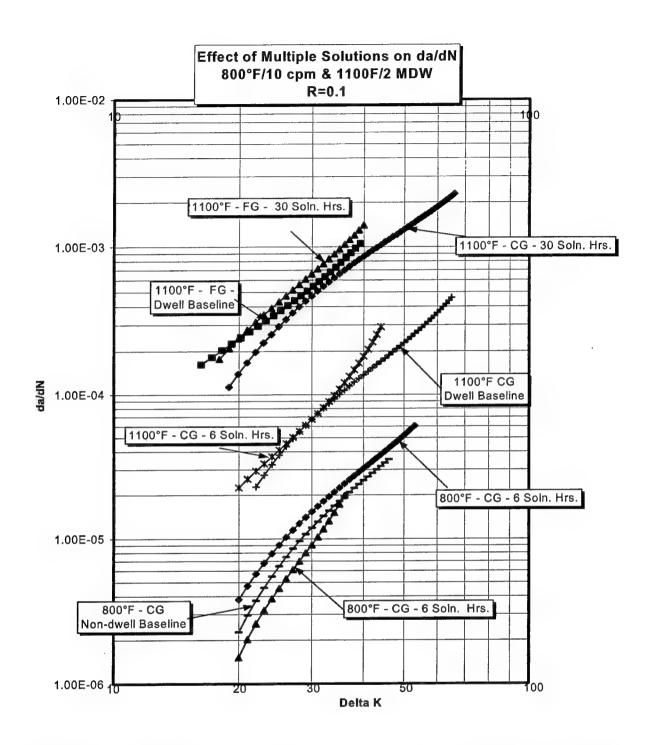
FIGURE 26. CRACK GROWTH RATE (da/dN) PLOTS OF AMS 5663 TESTED AT 800° AND 1100°F AFTER BEING EXPOSED TO SIX 1-HOUR SOLUTION (1750°F) EXPOSURES OR SIX 5-HOUR SOLUTION EXPOSURES (Note the relative ineffectiveness of a 6-hour exposure at both test conditions. The 30-hour exposure dramatically increases the crack growth rate of the coarse material tested under dwell loading at 1100°F but had no effect on the rate of the fine grain material.)

Two surprises arose from the AMS 5663 testing. One was the rate accelerating effect of a 30-hour solution exposure on coarse-grain AMS 5663 when tested at 1100°F/2 mdw, and the other was the effect that aging temperatures had on the crack growth characteristics of AMS 5663.

- The rate of accelerating effect of a 30-hour exposure was a surprise because it had been reported from earlier programs that multiple-solution exposures that generated more, even in excess, needle delta did not have such an effect. A recheck of the material used in those programs uncovered that the test material had been fine-grain forgings and not the as-reported coarse-grain forgings. Thus, the results of this program were consistent. It is noted that the upper end of the wrought Inconel 718, 1100°F dwell loading, crack growth scatter band is set by very fine grain forged material. Treatments of other forms of Inconel 718 may cause acceleration in the rate of crack growth but rarely creates rates that are faster. This is, except for over-aging, caused by extended exposure in the precipitation aging temperature range for the alloy.

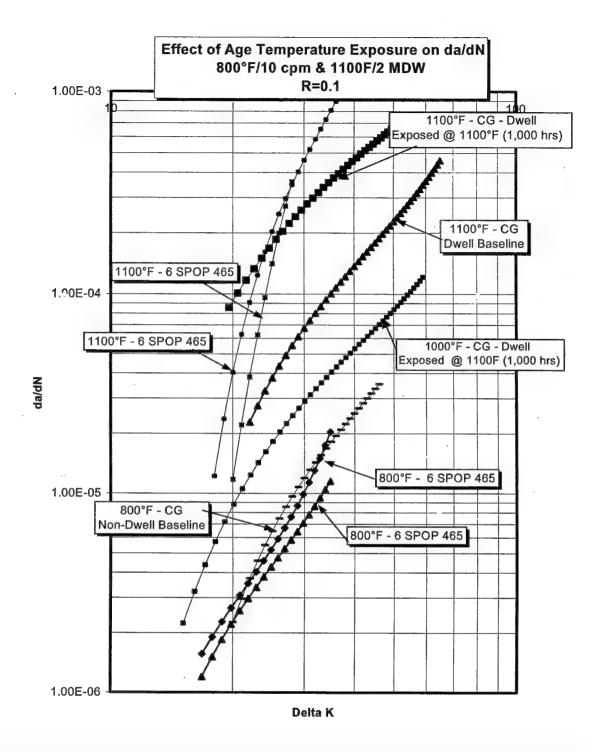
FIGURE 27. CRACK GROWTH RATE (da/dN) PLOTS FOR AMS 5663 TESTED AT 800°F/10 cpm, 1000°F/2 mdw, AND 1100°F/2-MINUTE DWELL AND R = 0.1 (Test material was exposed to six field repair short-age cycles (SPOP 465) or 1000 hours at 1100°F.)

- When this program was started, it was assumed that over-aging would have a minimal effect on the crack growth resistance of AMS 5663. However, both the long-time (1000 hours) exposure at 1100°F and the multiple-repair short ages caused an acceleration of AMS 5663's 1100°F/2-mdw crack growth rate. Of particular concern is when the effect of the short-age heat treat cycle is used without benefit of any resolution. Not only was the rate increased, but the rate of increase accelerated with crack growth. It is believed that multiple age only repair processing is used sparingly, if at all, on critical AMS 5663 components.

One of the objectives of the nonfunded portion of this contract program was to monitor the repair shops to determine exactly what repaired and reconditioned cases actually experience. In light of the dramatic effects the short-age process had on high-temperature crack growth rates, there are a number of actions that should be considered to mitigate against possible risk caused by using this process. One action would be to get the field information originally planned for this program to determine if the process is little or widely used. Second, the process should be evaluated for its

effect on AMS 5663 at temperatures between 800° and 1100°F. The long 1100°F exposure was found not to affect AMS 5663's crack growth rate at 1000°F, but the more damaging short-age process was only evaluated at 800° and 1100°F. More critical AMS 5663 components, such as the JT9D diffuser, operate at temperatures between these two levels. Finally, the process should be tested to determine if it affects the crack growth rate properties of finer grain AMS 5663.

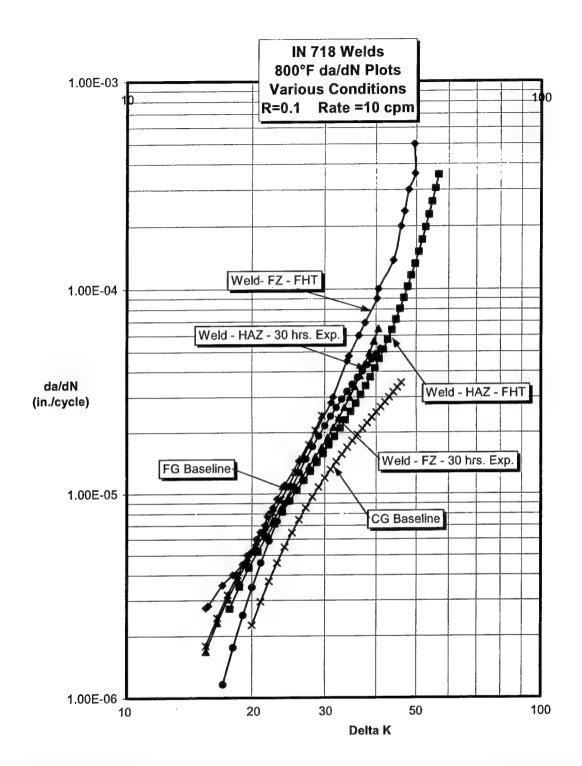
Crack growth rates of Inconel 718 GTA fusion welds fell between that of the coarse- and fine-grain base material rates at both 800°F/10-cpm (figure 28) and 1100°F/2-mdw (figure 29) test conditions. This was true for FZ and HAZ weld specimens. It was also true, for welds that were fully heat treated and for fully heat treated-plus-exposed to six 5-hour exposures at 1750°F. The

FIGURE 28. CRACK GROWTH RATE (da/dN) PLOTS OF AMS 5663 GAS TUNGSTEN ARC WELDS TESTED AT 800° F, R = 0.1 AND 10 cpm. (Note how all plots, FZ and HAZ, fall between the rates of coarse- and fine-grained base metal.)

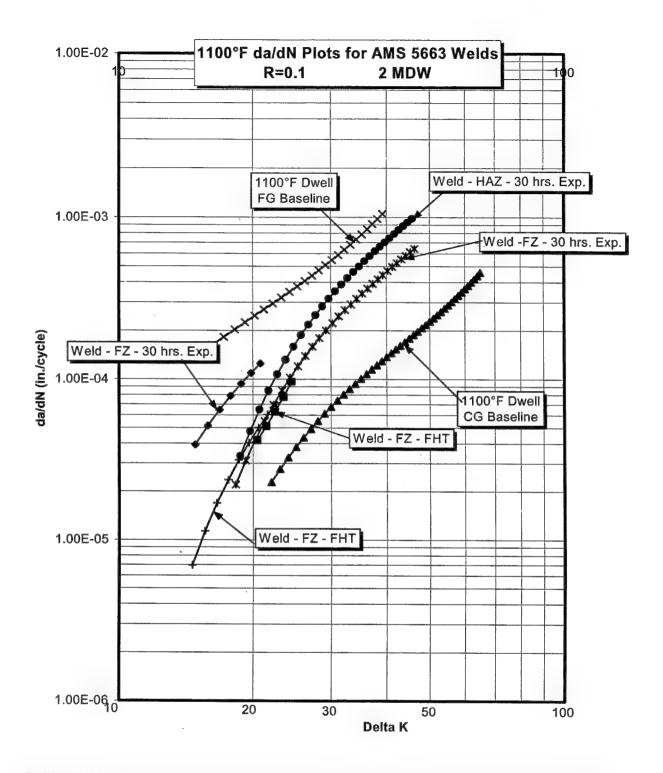
FIGURE 29. CRACK GROWTH RATE (da/dN) PLOTS OF AMS 5663 GAS TUNGSTEN ARC WELDS TESTED AT 1100°F, R = 0.1 AND 2-MINUTE DWELL AT MAXIMUM STRESS (Note how all plots, FZ and HAZ, fall between the rates of coarse- and fine-grained base metal.)

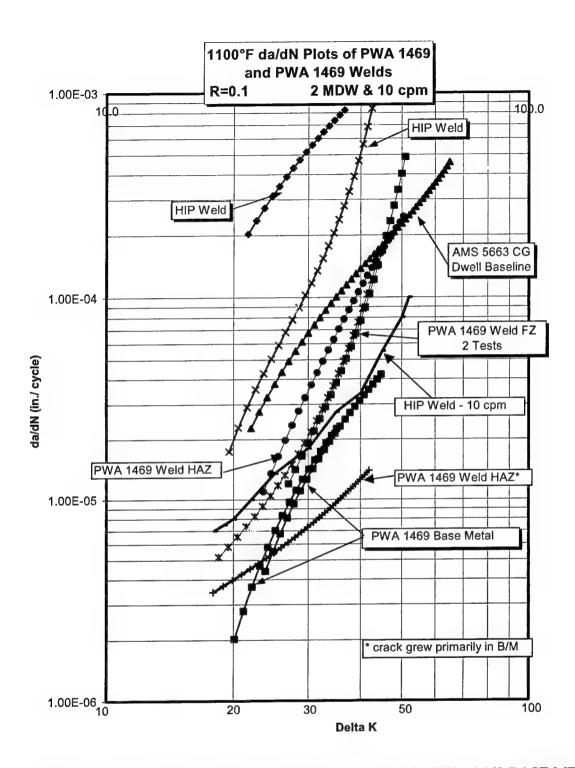
Figure 34 presents test results of base metal, welds, and HIP welds in the as fully heat-treated condition along with a plot of the coarse-grain AMS 5663 1100°F/2 mdw results which will serve as references. Rates of PWA 1469 are approximately 80% of that of the coarse-grain AMS 5663. Both of these baseline plots were within the 1100°F/10 cpm scatter band for PWA 1469. In fact, the two base metal plots were very close to the curve and are used as "typical" for PWA 1469 tested at nondwell conditions. As mentioned, one feature of large-grain cast Inconel 718 is its relative insensitivity to dwell loading.

FIGURE 34. CRACK GROWTH RATE (da/dN) PLOTS OF PWA 1469 BASE METAL, WELDS, AND HIP WELDS TESTED AT 1100°F, R = 0.1, AND UNDER 2-MINUTE DWELL AT MAXIMUM STRESS (One HIP weld was tested at 10 cpm. Weld cracks were centered either in the weld HAZ or FZ. The AMS 5663 coarse grain 1100°F dwell plot is included for reference.)

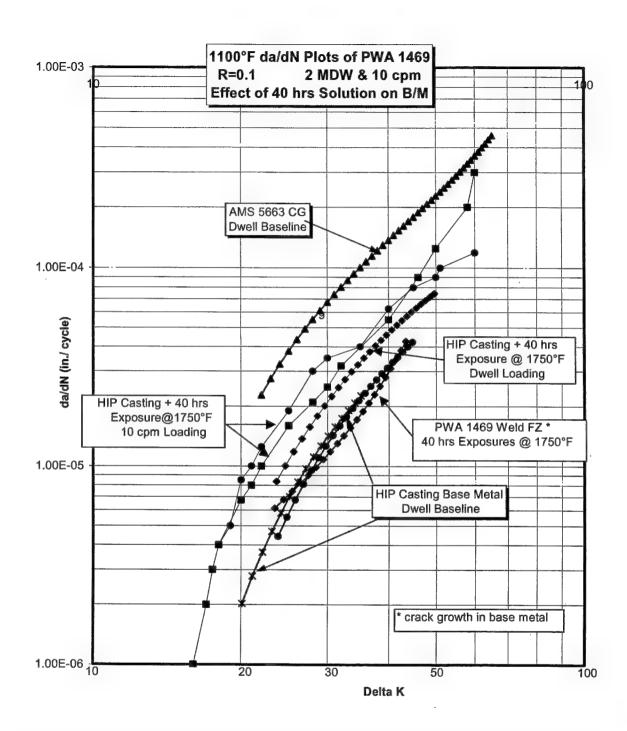
Exposures of up to 40 hours at the 1750°F temperature increased the rate of crack growth of the base metal at the 1100°F/2-mdw test condition by a modest factor of 1.5X (figure 35). The exposed base metal specimen tested at 1100°F/10 cpm actually had a slightly faster rate than the exposed metal tested under dwell conditions. These rates were on the high side of the scatter band of nonexposed base metal tested at 1100°F/10 cpm. Thus, all test results of PWA 1469 base metal, exposed and as fully heat treated, fell within a range that currently defines the database scatter band for PWA 1469 at 1100°F.

FIGURE 35. 1100°F CRACK GROWTH RATE (da/dN) PLOTS OF FULLY HEAT-TREATED PWA 1469 WITH A 40-HOUR EXPOSURE AT 1750°F (The coarse grain AMS 5663 and base PWA 1469 1100°F dwell plots are included for reference. Note that the exposed specimen run under 10 cpm loading has a faster rate then the dwell-loaded specimens.)

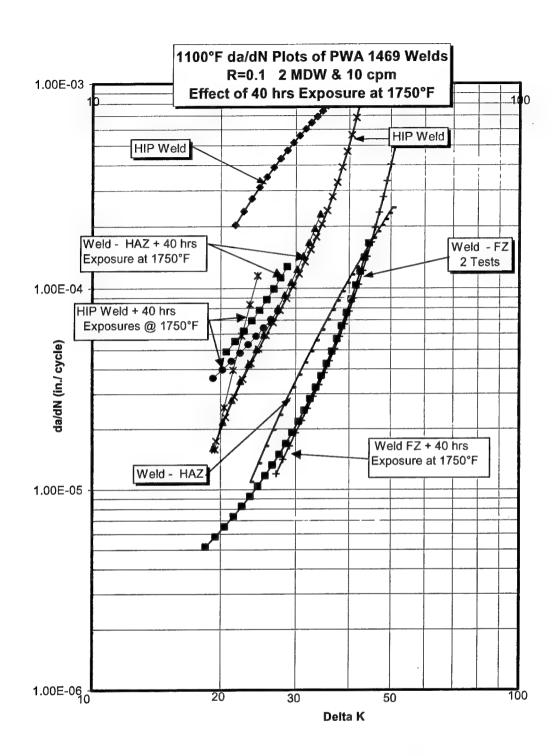
Exposures of up to 40 hours at the 1750°F solution temperature had mixed results on PWA 1469 welds (figure 36). One exposed fusion zone specimen had a rate that was slightly slower than the nonexposed fusion zone specimen. However, the two exposed HAZ, weld specimens had rates that were 5-6X faster than the nonexposed HAZ specimens. One followed the same plot as the slower nonexposed HIP weld while the other was slightly faster.

Under dwell loading, the two exposed HIP welds were only slightly faster rates than the slower two of nonexposed HIP weld specimens although one had a very steep slope to its plot.

FIGURE 36. 1100°F CRACK GROWTH RATE (da/dN) PLOTS OF PWA 1469 WELDS WITH A 40-HOUR EXPOSURE AT 1750°F (The exposure had an accelerating effect on the non-HIP weld HAZ specimens, but not so on the two other weld specimen types.)

As stated earlier, scatter among PWA 1469 da/dN plots is greater than the wrought materials. These results illustrate trends, but not enough tests were done to use the results to define design curves. Care must be taken against relying too much on the results of a few specimens to establish a design curve. Additional testing of HIP weld is especially warranted to confirm its behavior.

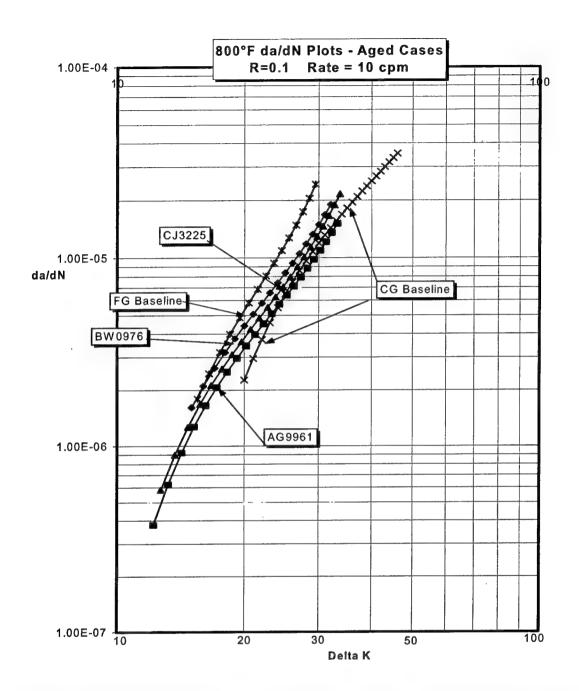
Specimens excised from the BA- and JAL-operated cases exhibited crack growth rates at 800°F/10-cpm conditions that were similar to that displayed by the coarse-grain AMS 5663 baseline material (figure 41). This was so despite the fact that material from the BA-operated case (BW0976) was substantially finer (figure 38) than the baseline material (figure 20).

FIGURE 41. CRACK GROWTH RATE (da/dN) PLOTS OF SPECIMENS EXCISED FROM LONG-TIME SERVICE CASES BW096, AG9961, AND CJ3225 TESTED AT 800°F, R = 0.1 AND 10 cpm (Note that all plots fall between the coarse and fine grain AMS5663 baseline plots.)

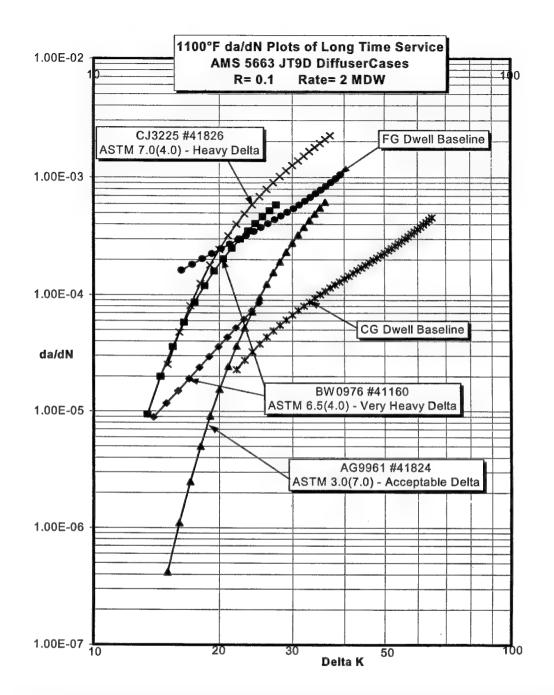
Crack growth rates of the aged case specimens were substantially faster than the coarse-grain baseline when tested under dwell-load conditions at 1000° and 1100°F (figures 42 and 43). The rates matched or surpassed those demonstrated by the material with six simulated short-age, postweld heat treat repairs and 1000 hours of exposure at 1100°F. Delta concentration within the BA case specimen was significantly greater than the baseline and simulated repair exposure specimens while the delta structure between the two JAL case specimens was more typical. However, one of the JAL cases (AG9961) had mixed grain sizes. Bands of coarse grains led to slower rates at 1100°F/2 mdw (figure 42).

FIGURE 42. CRACK GROWTH RATE (da/dN) PLOTS OF SPECIMENS EXCISED FROM LONG-TIME SERVICE CASES BW096, AG9961, AND CJ3225 TESTED AT 1100°F, R = 0.1 AND 2-MINUTE DWELL AT MAXIMUM STRESS (Note that all plots have a steeper slope than both the coarse and fine grain AMS5663 baseline plots. Also, that the faster rates of the case specimens appear more related to grain size then delta content.)

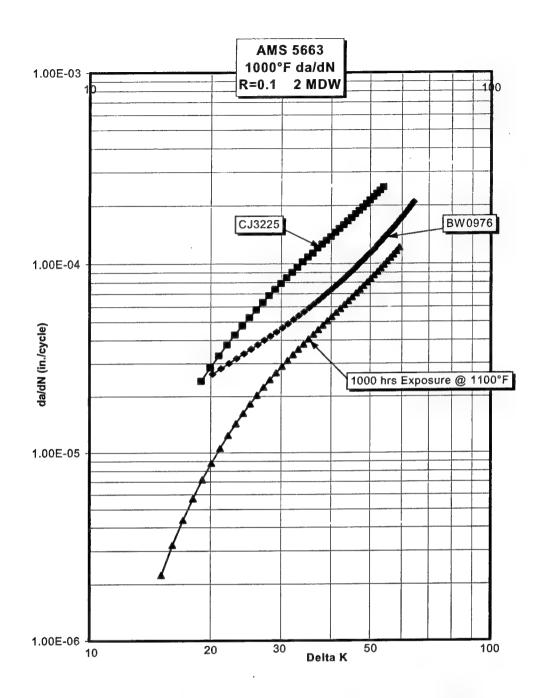
FIGURE 43. CRACK GROWTH RATE (da/dN) PLOTS OF SPECIMENS EXCISED FROM LONG-TIME SERVICE CASES BW096 AND CJ3225 AND COARSE-GRAIN AMS 5663 WITH A 1,000-HOUR EXPOSURE AT 1100°F (All tests were at 1000°F, R = 0.1 and 2-minute dwell at maximum stress.)

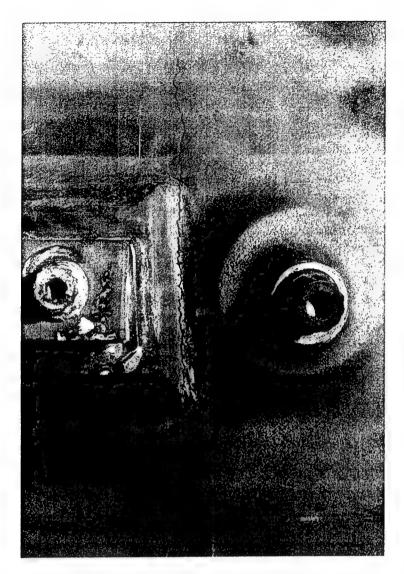
The first inspection of the slots was scheduled after 1000 cycles had occurred. However, because 7 of the 11 slots were located on the inner surface embossments, the case had to be completely removed from the test rig so the inspection could occur. After 684 cycles, there were noticeable pressure losses. An inspection of the case's outer surface revealed a crack in excess of 4" between the welded-on Tt3 boss and a nearby borescope inspection boss, (see figure 48). There was no evidence that any of the EDM slots had grown. The crack was excised using wire EDM after which the EDM racetrack-shaped hole was weld repaired, the case reheat treated, and returned to test. In addition to the 5" repair weld, numerous surface welds were placed on the outer surface to correct for distortion created by the large repair weld. It should be noted that a weld of this size would not be permitted on a service case. It was undertaken here to salvage the case for the sake of the test program.

FIGURE 48. CRACK IN OUTER PRESSURE WALL OF PW4000 DIFFUSER CASE CYCLED FOR 684 CYCLES IN THE HOT-CYCLE PRESSURE RIG (The crack runs axially adjacent to an instrumentation boss (left of the crack), the base that was created by the buildup of multiple layers of weld metal.)

As previously stated, the case used included welded-on boss configurations that were not consistent with a final commercial application design. This contributed to the early cracking of the case. The crack extended forward and aft of the Tt3 boss (see figure 48) and appeared to initiate in the fillet between the Tt3 boss and adjacent binocular bosses. After removal by EDM from the case wall, the crack was measured and found to extend 2.25" forward of the welded-in instrumentation boss and 1.875" rearward of the same boss for a total length of 4.125". The fatigue "thumbprint" measured approximately 0.050" along the outer surface wall and was 0.080" deep, coming within 0.010" of the wall's inner surface before rapid tensile tearing occurred. The origin of fatigue was centered in the fillet on a tangential line connecting the two bosses that straddled the fillet. Several factors contributed to the initiation of the crack.

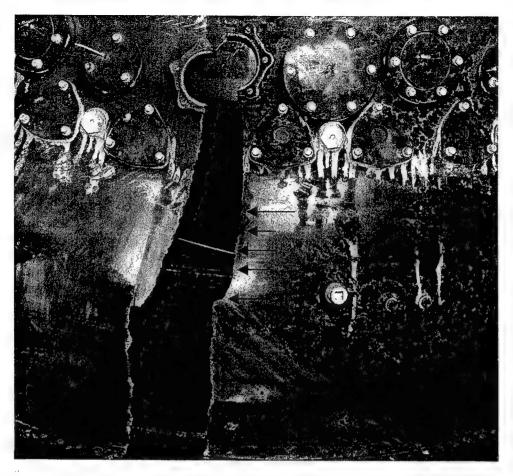
Completing the patch repair created distortions of the flanges to a degree that it made holding pressure in the rig difficult. The previous 2442 cycles had been generated with dwell loading. However, after an additional 152 cycles with dwell loading, it was decided to continue the test without dwell loading because it failed. Cyclic loading continued for an additional 2759 cycles with a full inspection (outer- and inner-wall surfaces) after 1012 cycles. Cracks were growing out of several, but not all, EDM slots. With the inspection at 5106 cycles, numerous cracks (0.065" to 0.355"in length) were observed in the vicinity of the patch weld. At 5350 cycles, a cluster of these cracks measured 1.2" long on the outer surface. Although the case was planned to run another 250 cycles, after 238 cycles, the case ruptured, see figure 49.

FIGURE 49. HOT-PRESSURE RIG DIFFUSER TEST CASE AFTER RUPTURE FOLLOWING 5589 CYCLES (Arrows mark major fatigue origin points along main fracture but there were numerous smaller crack indications along the fracture path at earlier inspections.)

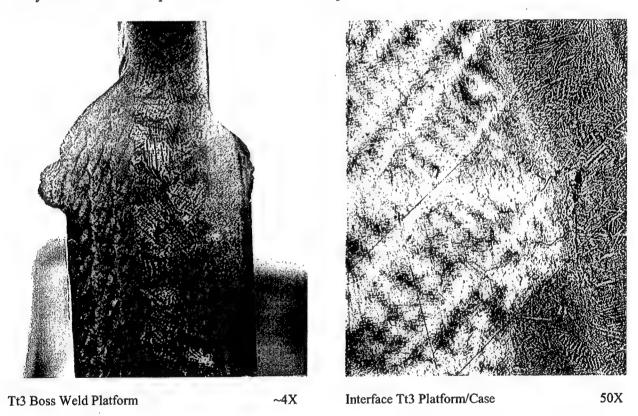
FIGURE 50. CROSS SECTION OF Tt3 BOSS PLATFORM FABRICATED WITH MULTIPLE LAYERS OF WELDS (Note the lack of fusion and HAZ cracks (right) associated with the rather massive welds.)

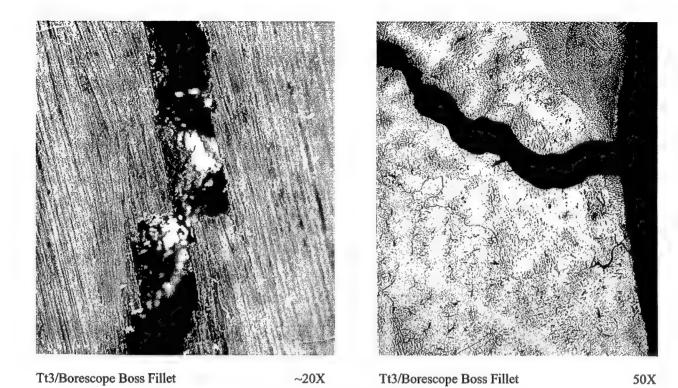
FIGURE 51. AREA BETWEEN THE Tt3 AND BORESCOPE BOSSES (Note the heavy grind marks on the outer surface (left) and weld material in the fillet (right). Both were associated with the case rupture fracture.)

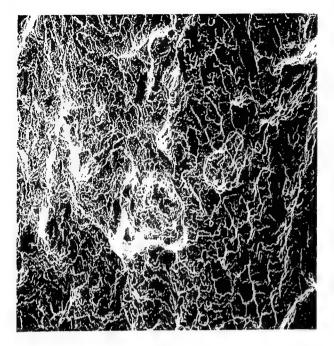
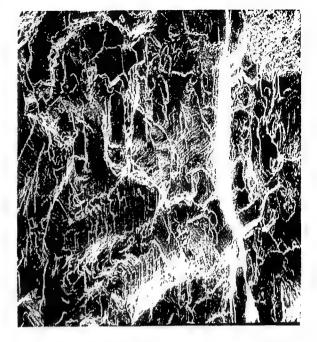
At completion of the second sequence of cyclic testing, a 0.990" long crack was detected near the 5-inch weld repair that was used to fill the EDM slot made in removal of the sequence 1 crack. It proved impossible to identify a single fatigue origin. Along the fracture length were areas of tensile overload (figure 52(a)), fatigue (figure 52(b)), fatigue + overload, and both transgranular (figure 53(a)) and intergranular (figure 53(b)) crack propagation. Multiple initiation sites were detected. These attributed to poor quality of the large repair weld and to the intersecting small surface welds that were used to correct the distortion caused by the large repair weld. Extensive secondary cracking was also observed. Secondary cracks were observed along grain boundaries of the exposed base material (figure 54(a)) and along delta plates (figure 54(b)) in areas of extremely high delta concentrations. Some of these areas exhibited levels of needle delta phase concentration in excess of that observed during the heat treat studies. This was attributed to exposing the case to delta-precipitating temperatures while residual stresses were imposed on the material, accelerating the precipitation process.

FIGURE 52. TENSILE OVERLOAD (LEFT) AND A COMBINATION OF TENSILE OVERLOAD PLUS FATIGUE (RIGHT) FRACTURE FEATURES FOUND THROUGHOUT THE MAIN CASE FRACTURE

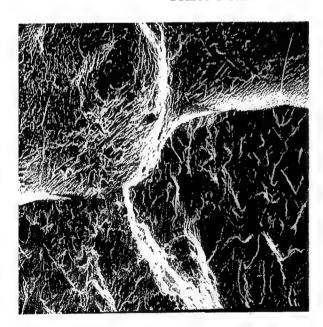
a. Transgranular Cracking

FIGURE 53. EXAMPLES OF CRACK GROWTH PROPAGATION BY A TRANSGRANULAR (LEFT) AND INTERGRANULAR (RIGHT) PATHS

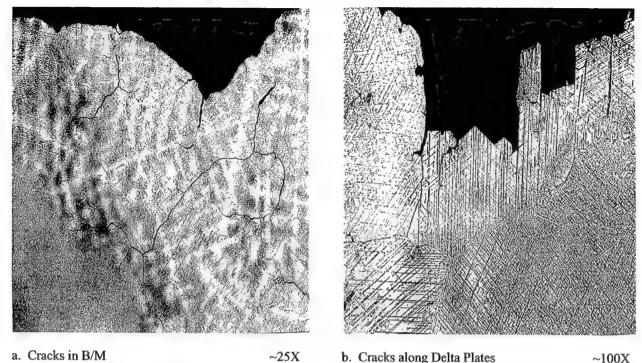
FIGURE 54. EXAMPLES OF SECONDARY CRACKS ALONG CAST BASE METAL GRAIN BOUNDARIES (LEFT) AND DELTA PLATES (RIGHT)

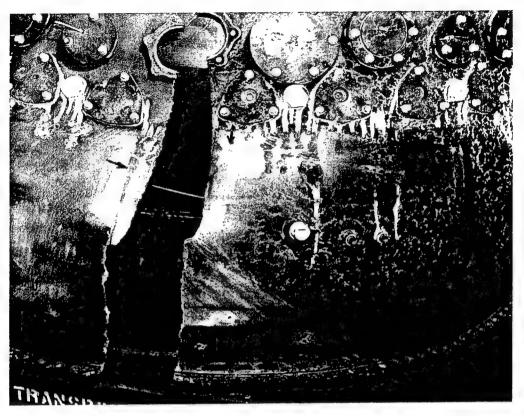
PWA 1469 Hot Rig Test Case

Five thumbprints were identified along the main fracture surface. These are indicated in figure 56. All grew from the outer surface inward. The largest measured 1.5625" along the outer surface and extended to the inner surface. The others ranged in length along the outer surface from 0.4375" to 0.5625" and extended from approximately 1/3 to 3/4 of the wall's thickness. Obviously the larger thumbprints represent linking up of the many smaller fluorescent

penetrant indications (FPI) detected at 5350 cycles that measured almost 1.2" in length. A more detailed analysis of the test case's main rupture growth characteristics is presented in task 2.

FIGURE 56. LEFT SIDE OF MAIN FRACTURE WITH FIVE FATIGUE THUMBPRINTS INDICATED BY BRACKETS (The largest (no. 1) measured 1.5625" in length and was located in the area where the 1.2" string of indications was observed at 5350 cycles.)

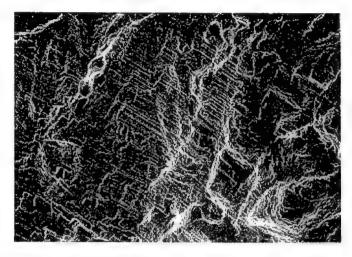
a. Major Crack Thumbnail No. 1

The thumbprints had relatively clear indications of the fatigue crack progression from the outer toward inner surfaces. However, there was also evidence of fatigue in the fracture areas between the thumbprints. Examples of the two areas are illustrated in figure 57. Numerous small intergranular cracks were observed near the main fracture that had the appearance of weld HAZ grain-boundary liquation cracks. A macroetched case section with the main fracture (figures 58 and 59) confirmed that the main fracture was near, but did not initiate or grow to any extent within the patch repair welds. Instead, cracking that led to the case rupture appears to have occurred from the numerous shallow welds. These shallow welds were made on the outer surface in an attempt to mitigate the distortion created by the large patch repair. Figure 60 presents photographic images of a typical surface crack and a HAZ crack emanating from a shallow weld.

FIGURE 57. FRACTOGRAPHIC PHOTOGRAPHS OF FATIGUE OBSERVED ON THE FRACTURE SURFACE OF THE HOT RIG TEST CASE MAIN RUPTURE (The examples were taken within thumbnail no. 1 (a) and between thumbnails nos. 2 and 3.)

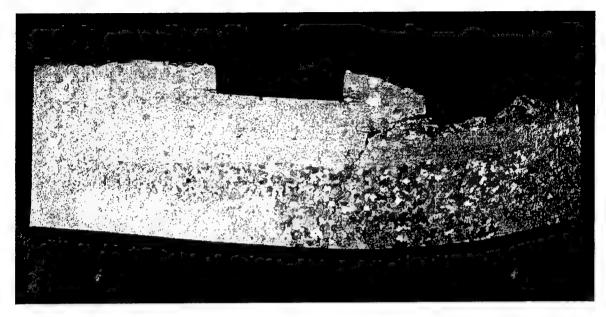
Main Case Rupture

Outer Surface

FIGURE 58. MACROETCHED OUTER SURFACE OF HOT-PRESSURE TEST RIG CASE ILLUSTRATING STRUCTURE NEAR THE MAIN CASE FRACTURE (Largest and probable initial fatigue site was within the section cut out of the center of the illustrated section. Note that it is some distance from the patch repair weld which runs left to right approximately in the middle of the excised section.)

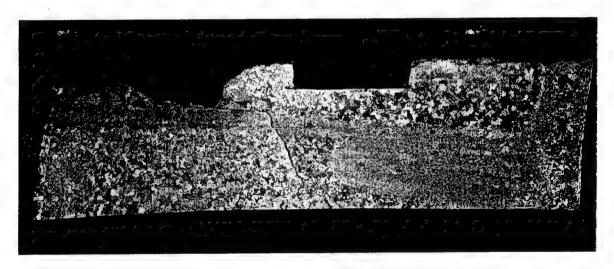
Main Case Rupture

Inner Surface

FIGURE 59. MACROETCHED INNER SURFACE OF HOT-PRESSURE TEST RIG CASE ILLUSTRATING STRUCTURE NEAR THE MAIN CASE FRACTURE (Note the clear delineation of coarse grains of the cast repair patch up to the fracture surface.)

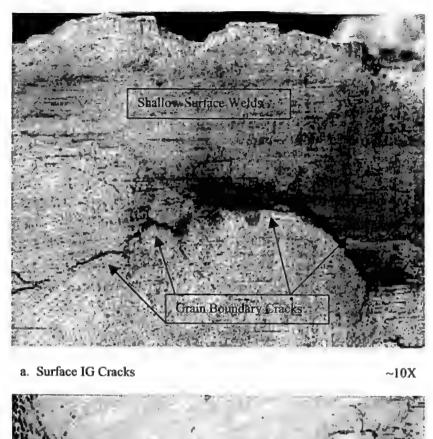
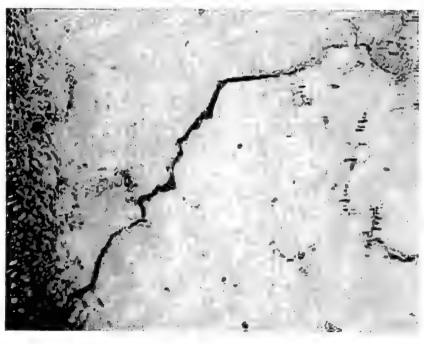
FIGURE 60. TYPICAL INTERGRANULAR SURFACE CRACKS (a) OBSERVED ON THE HOT-PRESSURE TEST RIG CASE IN THE VICINITY OF THE CASE RUPTURE FRACTURE CRACKS PROVED TO BE WELD HAZ GRAIN-BOUNDARY LIQUATION CRACKS AND (b) COMMONLY FOUND WITH WELDS OF CAST INCONEL 718. (These are typically caused by high restraint, poor welder technique or when welds are too large and/or too many such that they overlap each other.)

b. HAZ crack

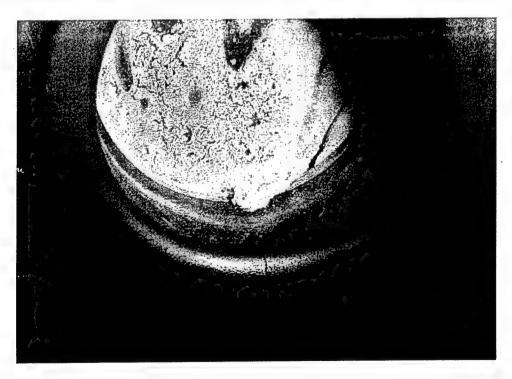
At completion of the test, cracks were evident at 7 of the 11 EDM slots that were located on the inner surface embossments of the integrally cast bosses. None of the smooth surface, pressure-wall EDM slots, including the three at welds, showed any evidence of crack progression. Figure 61 illustrates the crack observed at location no. 2 at completion of the pressure rig test.

FIGURE 61. CRACK EXTENDING OUT OF AN EDM SLOT ON THE INNER SURFACE EMBOSSMENT OF LARGE SERVICE BOSS 34 (LOCATION NO. 2.) (The crack has grown into the boss neck, parallel with the inner surface.)

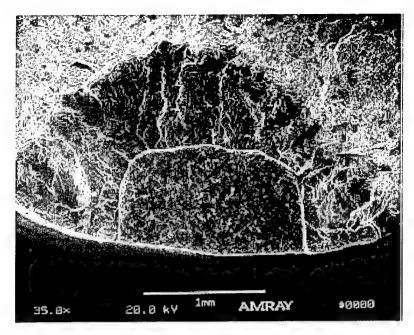
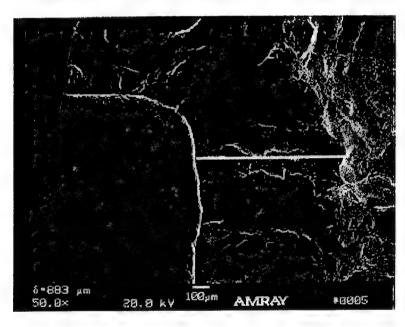
b. EDM Slot No. 3

FIGURE 62. SECONDARY ELECTRON IMAGES OF EDM SLOT NO. 3 AFTER IT AND THE ASSOCIATED CRACK WAS OPENED UP (a) IS AN OVERALL VIEW OF THE SLOT AND FRACTURE AND (b) ILLUSTRATES THE LINE ALONG WHICH THE CRACK LENGTH WAS MEASURED FROM THE SLOT INTO THE EMBOSSMENT

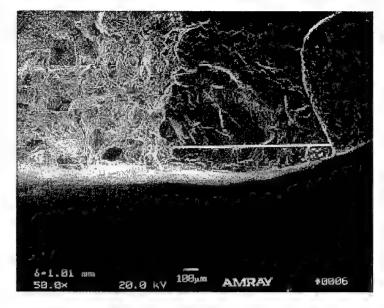
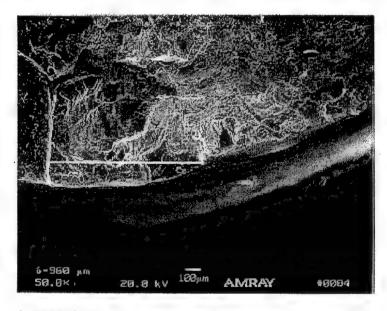
FIGURE 63. SECONDARY ELECTRON IMAGES OF EDM SLOT NO. 3 AFTER IT AND THE ASSOCIATED CRACK WAS OPENED UP (c) WHITE LINES EXTENDING FROM THE EDM SLOT EDGE REPRESENT WHERE THE CRACK LENGTH WAS MEASURED ALONG THE INNER-WALL SURFACE AND (d) ALONG THE BOSS NECK

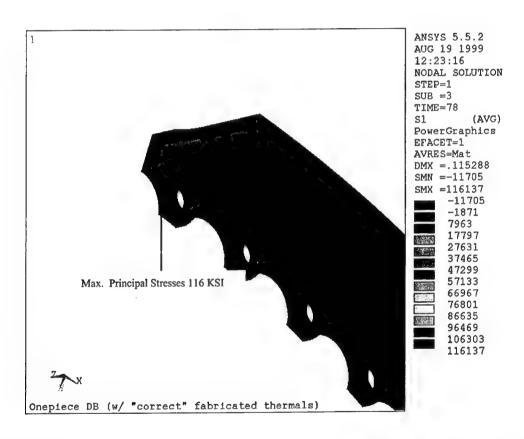
gradient on the boss. The maximum stress location of the flange was at the flange inner fillet and had a value of 116 ksi, as shown in figure 80, and in the boss areas at the weld fillet as indicated in figures 81 and 82. The analytical predictions agree well with the location of the CCOC field-cracking experience. Submodels of the drain boss and Ps4 boss were analyzed to acquire the maximum concentrated stresses of the two bosses at the weld toe. Figure 83 shows the submodels cuts at the critical locations of the bosses. A typical weld-to-case wall fillet radius of 0.005" was implemented in all submodels. Figure 84 shows the mesh density of the submodels. An analysis was performed using the displacement boundary conditions from results of the 3D full models at the operating points of 10 and 78 sec. Results from the submodel analyses are presented in tables 32 and 33. The maximum stress of the drain boss is predicted as 136.8 ksi at the operating time of 78 sec and 129.5 ksi for the Ps4 boss at the same operating time. Maximum principal stress distributions of the drain and Ps4 bosses are shown in figures 85 and 86.

FIGURE 80. MAXIMUM STRESS LOCATION AT THE CCOC REAR FLANGE

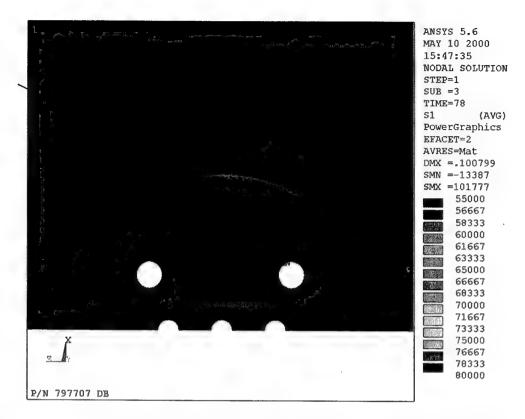
Maximum principal stresses at the boss weld fillet

FIGURE 81. MAXIMUM STRESS LOCATION AT THE DRAIN BOSS WELD

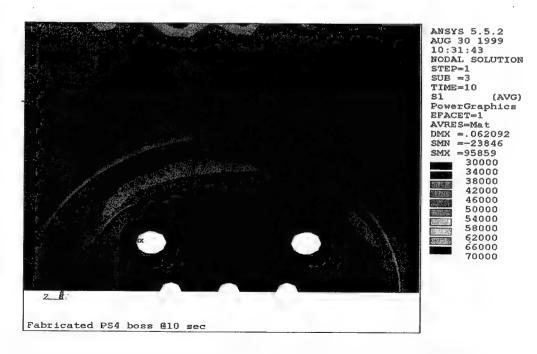
Maximum stresses at the boss weld fillet

FIGURE 82. HIGH STRESSES AT THE Ps4 BOSS WELD REGION

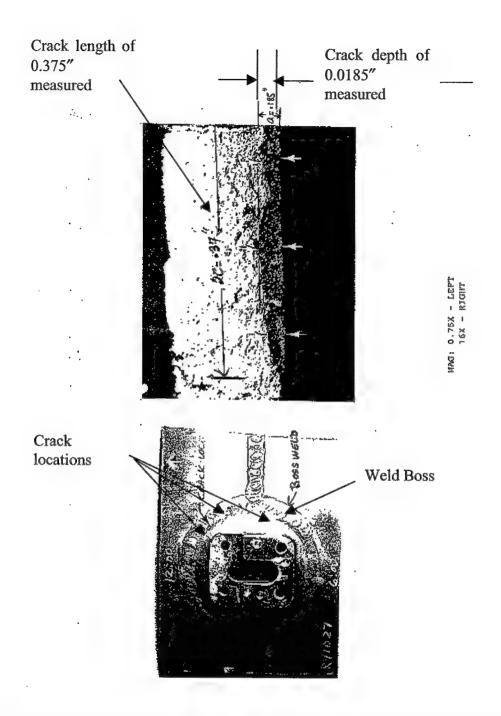
FIGURE 89. JT8D CCOC TYPICAL REAR DRAIN BOSS CRACK WITH MULTIORIGINS

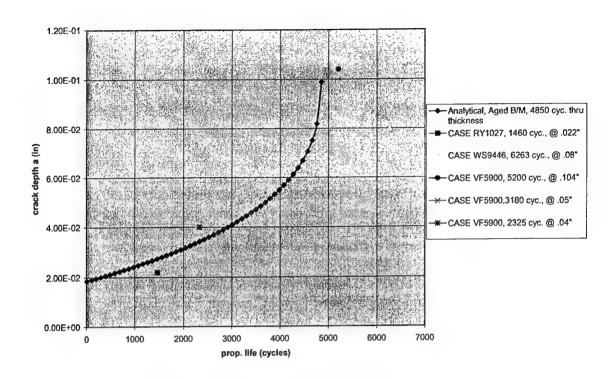
A review of CCOC cracking shows that cracks initiate and propagate inside the base metal, adjacent to the weld bead of the drain boss. The crack growth model for welded, aged steel alloy at 750°F was used to calculate crack propagation for a crack progressing through the case wall. The analysis was carried out using surface crack option in SURCK with an initial aspect ratio of 0.0185" x 0.370". Predicted crack growth vs cycles is plotted in figure 91. A total life of 4850 cycles was predicted for the crack to pass through the case thickness and transition to a throughwall crack with a surface length of 2 inches. Predicted propagation life was calibrated using striation data from three cracked field cases, which is also plotted in figure 91. Good agreement exists between the predicted and measured data. Figure 92 plots the crack length instead of crack depth. A second fracture mechanics analysis was performed in which a center crack was analyzed to simulate the through thickness cracks propagation along the case wall. The center crack analysis predicted 700 cycles for the crack to propagate and reach critical crack length. The total crack growth life from initiation to rupture is predicted to be 5550 cycles, which agrees well with operational experience.

FIGURE 91. JT8D-219 CCOC DRAIN BOSS CRACK PROPAGATION LIFE THROUGH THICKNESS WERE CALIBRATED WITH FIELD DATA

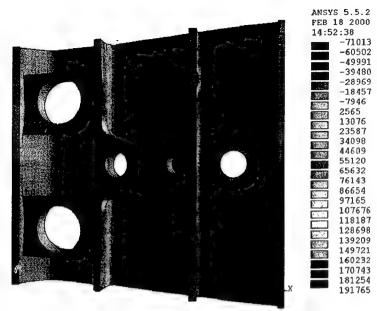
FIGURE 128. PRINCIPAL ELASTIC STRESS DISTRIBUTION FOR CRACKED BOSS 6 $(0.290 \times 0.400 \text{ surface crack on rail})$

338-7602 JT9D Diffuser case, boss6, t=28sec, Structural analysis

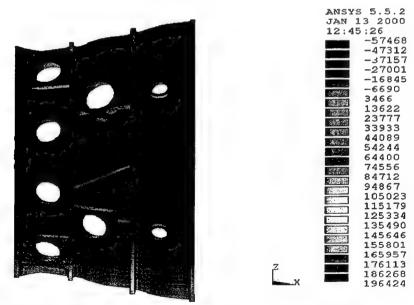
FIGURE 129. PRINCIPAL ELASTIC STRESS DISTRIBUTION FOR CRACKED BOSS 7&8 (0.290 × 0.400 in. surface crack on rail)

338-7602 JT9D Diffuser case - boss7-8, t=26s. Elastic Analysis.

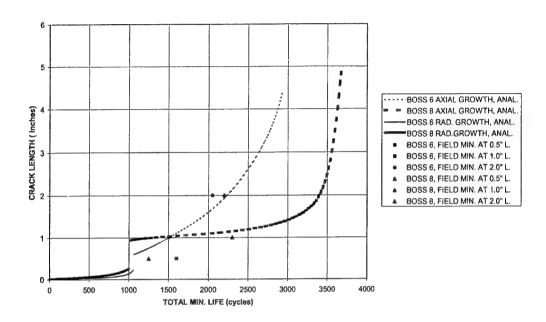
FIGURE 138. JT9D-DC REAR RAIL MINIMUM RESIDUAL LIFE USING SURCK PREDICTIONS

Following the edge crack analysis, a through thickness wall crack analysis was performed. The stress gradients calculated for the case wall on both sides of the rail were applied to the crack model. Crack propagation life predictions, are presented in figures 138 and 139. Figure 138 was based on minimum life predictions, while figure 139 was based on typical predictions. In these two plots, the predicted crack propagation life cycle for the case wall were combined with the corner crack propagation life in one single plot showing the total life profile from corner crack propagation at the top of the rail to a critical through wall crack. The curves are discontinued in the middle, where the edge crack transitions from a corner crack to a through wall crack where no crack propagation was predicted. The small curve to the left is the corner crack propagation along the rear rail and the longer one is the axial growth along the case wall. The residual life predictions from SURCK for typical and minimum lives were then compared with field data. The minimum predictions in figure 138 are compared with calculated minimum lives based on field data, while the typical predictions in figure 139 are compared with actual field measured cracks. The analysis shows reasonable agreement with engine data, although the typical data

appears to be underpredicted once the crack goes through the case wall. In addition, SURCK does not predict a significant difference in either life or critical crack size between boss 6 and boss 7&8 as seen in operation, since it cannot account for load redistribution as the crack propagates.

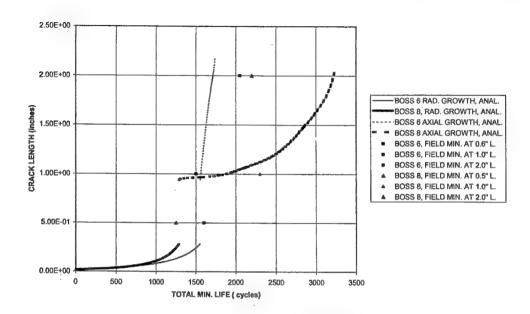
FIGURE 140. JT9D-DC REAR RAIL MINIMUM RESIDUAL LIFE USING FRANC-3D PREDICTIONS

A similar calibration was performed using FRANC-3D life predictions with the results plotted in figures 140 and 141. Figure 140 shows the minimum predicted residual life for the crack starting at the top of the rail and progressing to a through wall crack. Figure 141 presents the typical predictions. FRANC-3D does a better job than SURCK in predicting the observed differences between the critical crack sizes at the two boss locations because FRANC-3D can account for the load redistribution to the adjacent bosses and rail as the crack grows.

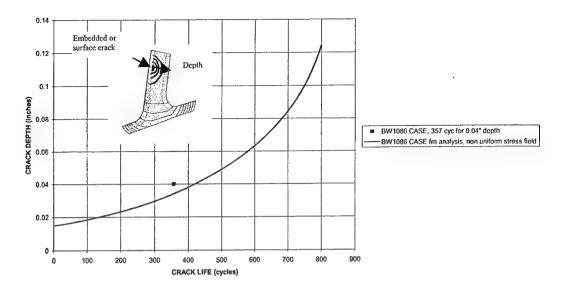
FIGURE 143. JT9D-DC WELDED/REPAIRED REAR RAIL FM ANALYSIS, CASE BW 1086 WELD DEFECT SIZE ~ 0.12" x 0.015"

Case BW 1086 is a JT9D-7 diffuser case that had accumulated 904 cycles since its last weld repair when investigation found a 14.75" crack between boss 6 and 7 during an engine removal due to surge and over temperature. The crack had progressed in LCF from a 0.120" x 0.015" weld defect on the front face of the rail. Results of the analysis predict a residual life of ~ 800 cycles along the rear rail as shown in figure 143. The measured crack growth (striation counts) in the rail has been added to figure 143 and shows good agreement with the predictions.

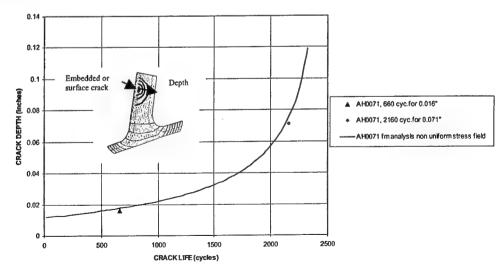
FIGURE 144. JT9D-DC REAR RAIL WELDED/REPAIRED FM ANALYSIS, CASE AH 0071 DEFECT SIZE 0.035" x 0.012"

Case AH 0071 is a JT9D-7A diffuser case that accumulated 3264 cycles since its last weld repair, and exhibited an 8" axial crack through the rear rail and through the adjacent walls of the case. The crack was due to LCF that progressed from origins at subsurface- and surface-connected weld abnormalities adjacent to boss 6. The weld defect size was approximately 0.035" x 0.012". The analysis predicts that this case had a life of 2323 cycles for this crack to transition through the rail as shown in figure 144. Measured field data (striation counts) were plotted on the same graph for comparison. Analytical predictions are in good agreement with measured field data.

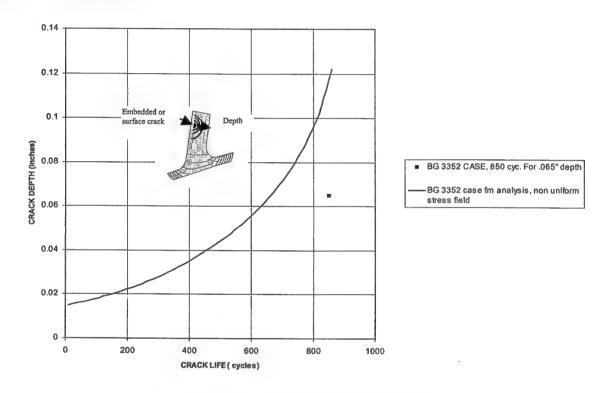
FIGURE 145. JT9D-DC WELDED/REPAIRED REAR RAIL FM ANALYSIS, CASE BG 3352, DEFECT SIZE 0.110" x 0.015"

Case BG 3352 is a JT9D-7A diffuser case that accumulated 11,669 cycles in service. A crack that propagated in LCF was initiated from a weld defect approximately 0.110" x 0.015" in size on the front surface of the rear rail. Analysis predicts that this case has a crack growth life of 859 cycles to progress through the rail width axially (results are plotted in figure 145). Measured field data (striation counts) showed that the case had between 700 to 1000 cycles (average 850 cycles) of crack progressions on the rail before it changed to an overload tensile progression. The measured distance of LCF progression is 0.05". Analytical prediction is conservative with respect to the field data.

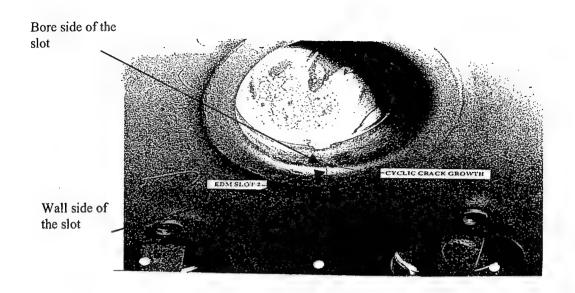
FIGURE 146. EDM SLOT 2 AND CYCLIC CRACK GROWTH

EDM slot 2 was placed on the fillet radius of a customer bleed boss and is shown in figure 146 along with subsequent crack growth from the slot. This location was selected to obtain crack growth data because it is at the location of a stress concentration and thus a possible location of cracking in the field. Figure 147 presents a comparison of EDM slot 2 crack growth data with analytical predictions from the linear elastic SURCK code. The 2D stress field in conjunction with a corner crack model correlates reasonably well with the crack lengths from FPI measurements. The 1125°F crack growth law used in the analysis has been interpolated from 1100° and 1175°F specimen testing under nondwell conditions. The testing previously reported did not include dwell period during EDM slot crack growth due to the effect of leakage (from distortion due to weld patch repair) and the inability of the furnace to hold temperature with excessive rig through flows. Minimizing the time the case was pressurized limited both heat loss and temperature drop.

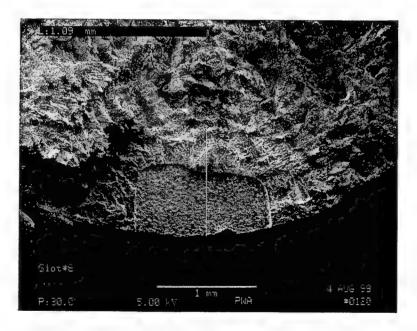
FIGURE 149. PHOTOMICROGRAPH OF SLOT 8 AFTER THE CRACK WAS BROKEN OPEN (Fracture beyond these points was primarily by tensile overload.)

The crack growth prediction of slot 8 (large service boss corner location) was made by using the corner crack formulation in SURCK along with a 2D stress distribution derived from a NASTRAN analysis. Stress results are shown in figure 148, while figure 149 shows the fractured section of slot 8. Figure 150 compares the predicted crack growth results with the measured growth. The correlation appears reasonable until the last data point. Considering a da/dN scatter factor of 1.5 exists for this material, this data point would be covered in the material property scatter.

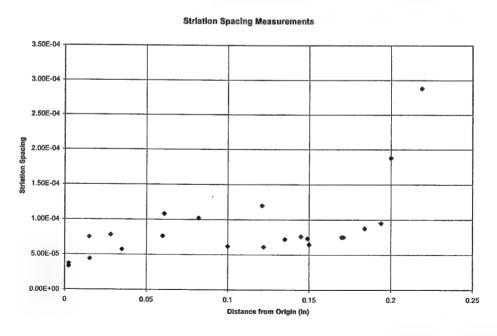
FIGURE 153. STRIATION DATA OBTAINED FROM THE 4.125" LONG CASE CRACK

The striation data, shown in figure 153, taken from the 4.125" long crack show the rate of crack propagation through the thickness of the case wall. Although unexpected, this crack incident provided additional crack growth data to be used in the crack growth analysis evaluation. Although the crack occurred from a boss produced from a nonproduction process, it is a good representation of what could occur in a field-operated case if good design practices are not followed.

The striation data (figure 153) represent crack growth from the engine conditions as well as from the rig cycling. A break in the data occurs near the 0.122 in. depth area. It is assumed that the engine striations end and the rig striations begin at or near this point.

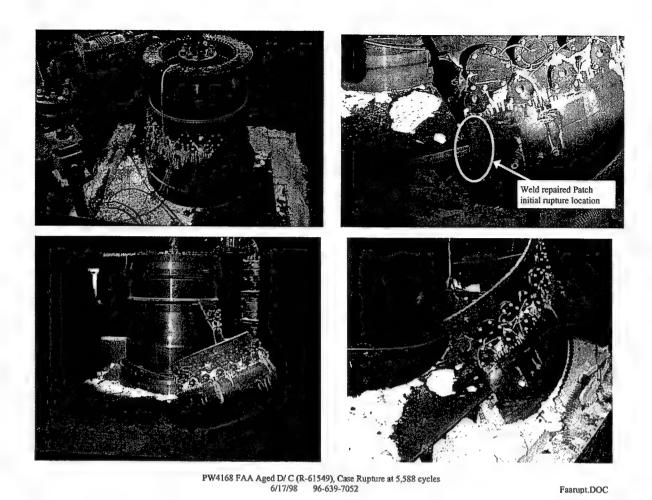
FIGURE 164. CASE RUPTURE IN THE CYCLIC PRESSURE RIG

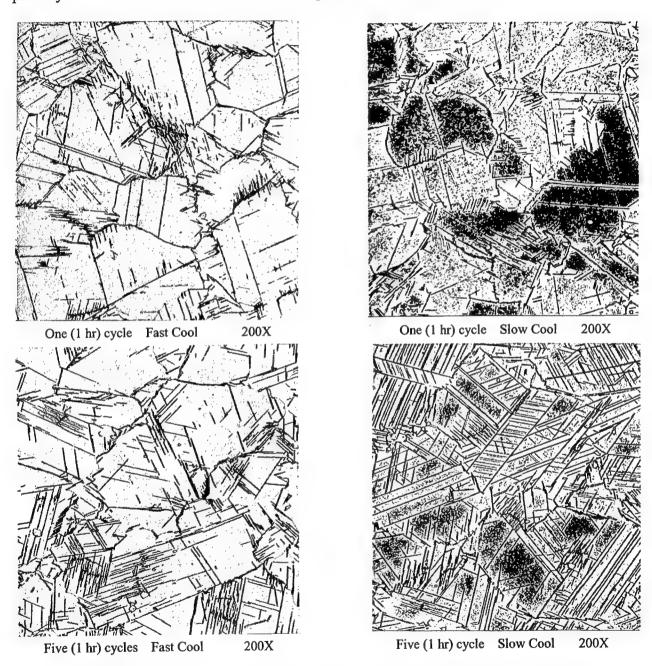
Between the cooling rates more typically experienced when processing cases, a slower cooling rate did result in the precipitation of more needle delta phase. Within any cooling rate the effect of more cycles at shorter times did not seem to be a factor. Total time at temperature was the primary factor with the amount of needle delta phase that was precipitated.

FIGURE B-1. TYPICAL MICROSTRUCTURES ILLUSTRATING DELTA CONCENTRATION IN FULLY HEAT-TREATED COARSE GRAIN AMS 5663 WITH A TOTAL OF 1 (UPPER) AND 5 (LOWER) HOURS AT THE 1750°F SOLUTION TEMPERATURE (Material was both fast cooled (left) and slow cooled (right) from solution prior to precipitation aging.)

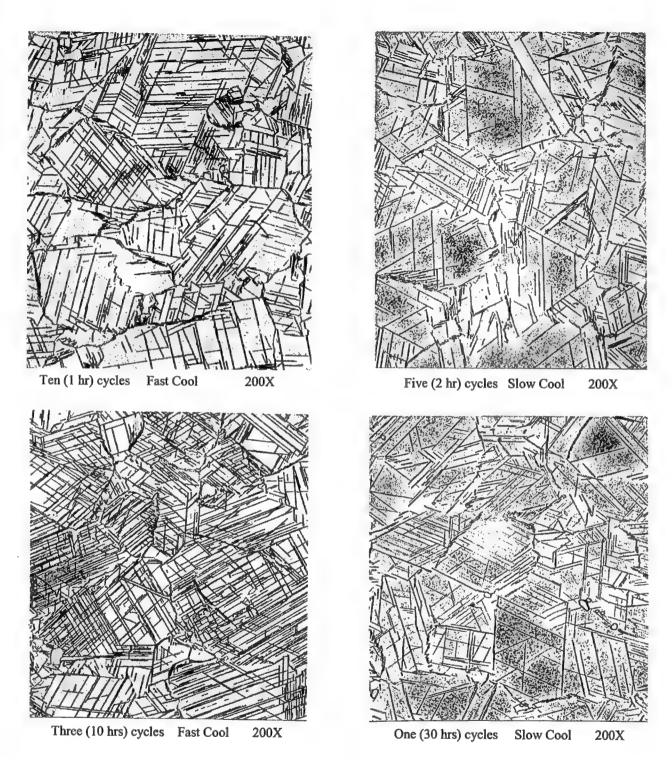
FIGURE B-2. TYPICAL MICROSTRUCTURES ILLUSTRATING DELTA CONCENTRATION IN FULLY HEAT-TREATED COARSE GRAIN AMS 5663 WITH A TOTAL OF 10 (UPPER) AND 30 (LOWER) HOURS AT THE 1750°F SOLUTION TEMPERATURE (Material was both fast cooled (left) and slow cooled (right) from solution prior to precipitation aging.)

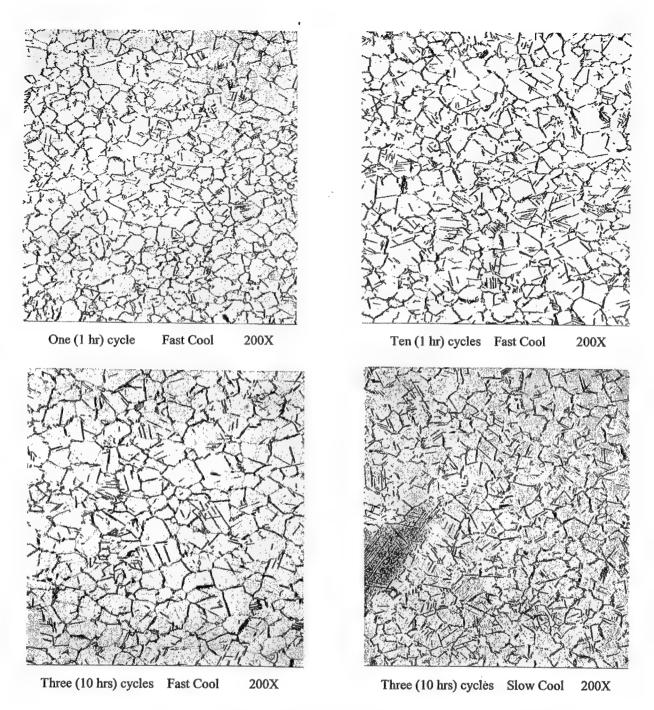
Very little needle delta phase precipitated within the fine grain material. This was true at both the grain boundary and intragranular regions. Further studies would be necessary to determine the reason for this, but it may be related to the fact that the fine grain barstock used in this evaluation had a considerable amount of globular delta phase in its grain boundaries. It is possible this reduced the drive to precipitate additional delta phase.

FIGURE B-3. TYPICAL MICROSTRUCTURES OF FULLY HEAT-TREATED FINE GRAIN AMS 5663 WITH 1 (UPPER LEFT), 10 (UPPER RIGHT), AND 30 (LOWER) TOTAL HOURS AT 1750°F (All were fast cooled from solution except that illustrated in the lower right photomicrograph.)
